# Rodney Tree Evaluation

**CITY OF NEWARK**  
**PUBLIC WORKS & WATER RESOURCES DEPARTMENT**  
REDEVELOPMENT OF THE RODNEY COMPLEX -  
PUBLIC PARK SITE AMENITIES

SHEET TITLE:  
**EXISTING TREE EXHIBIT**

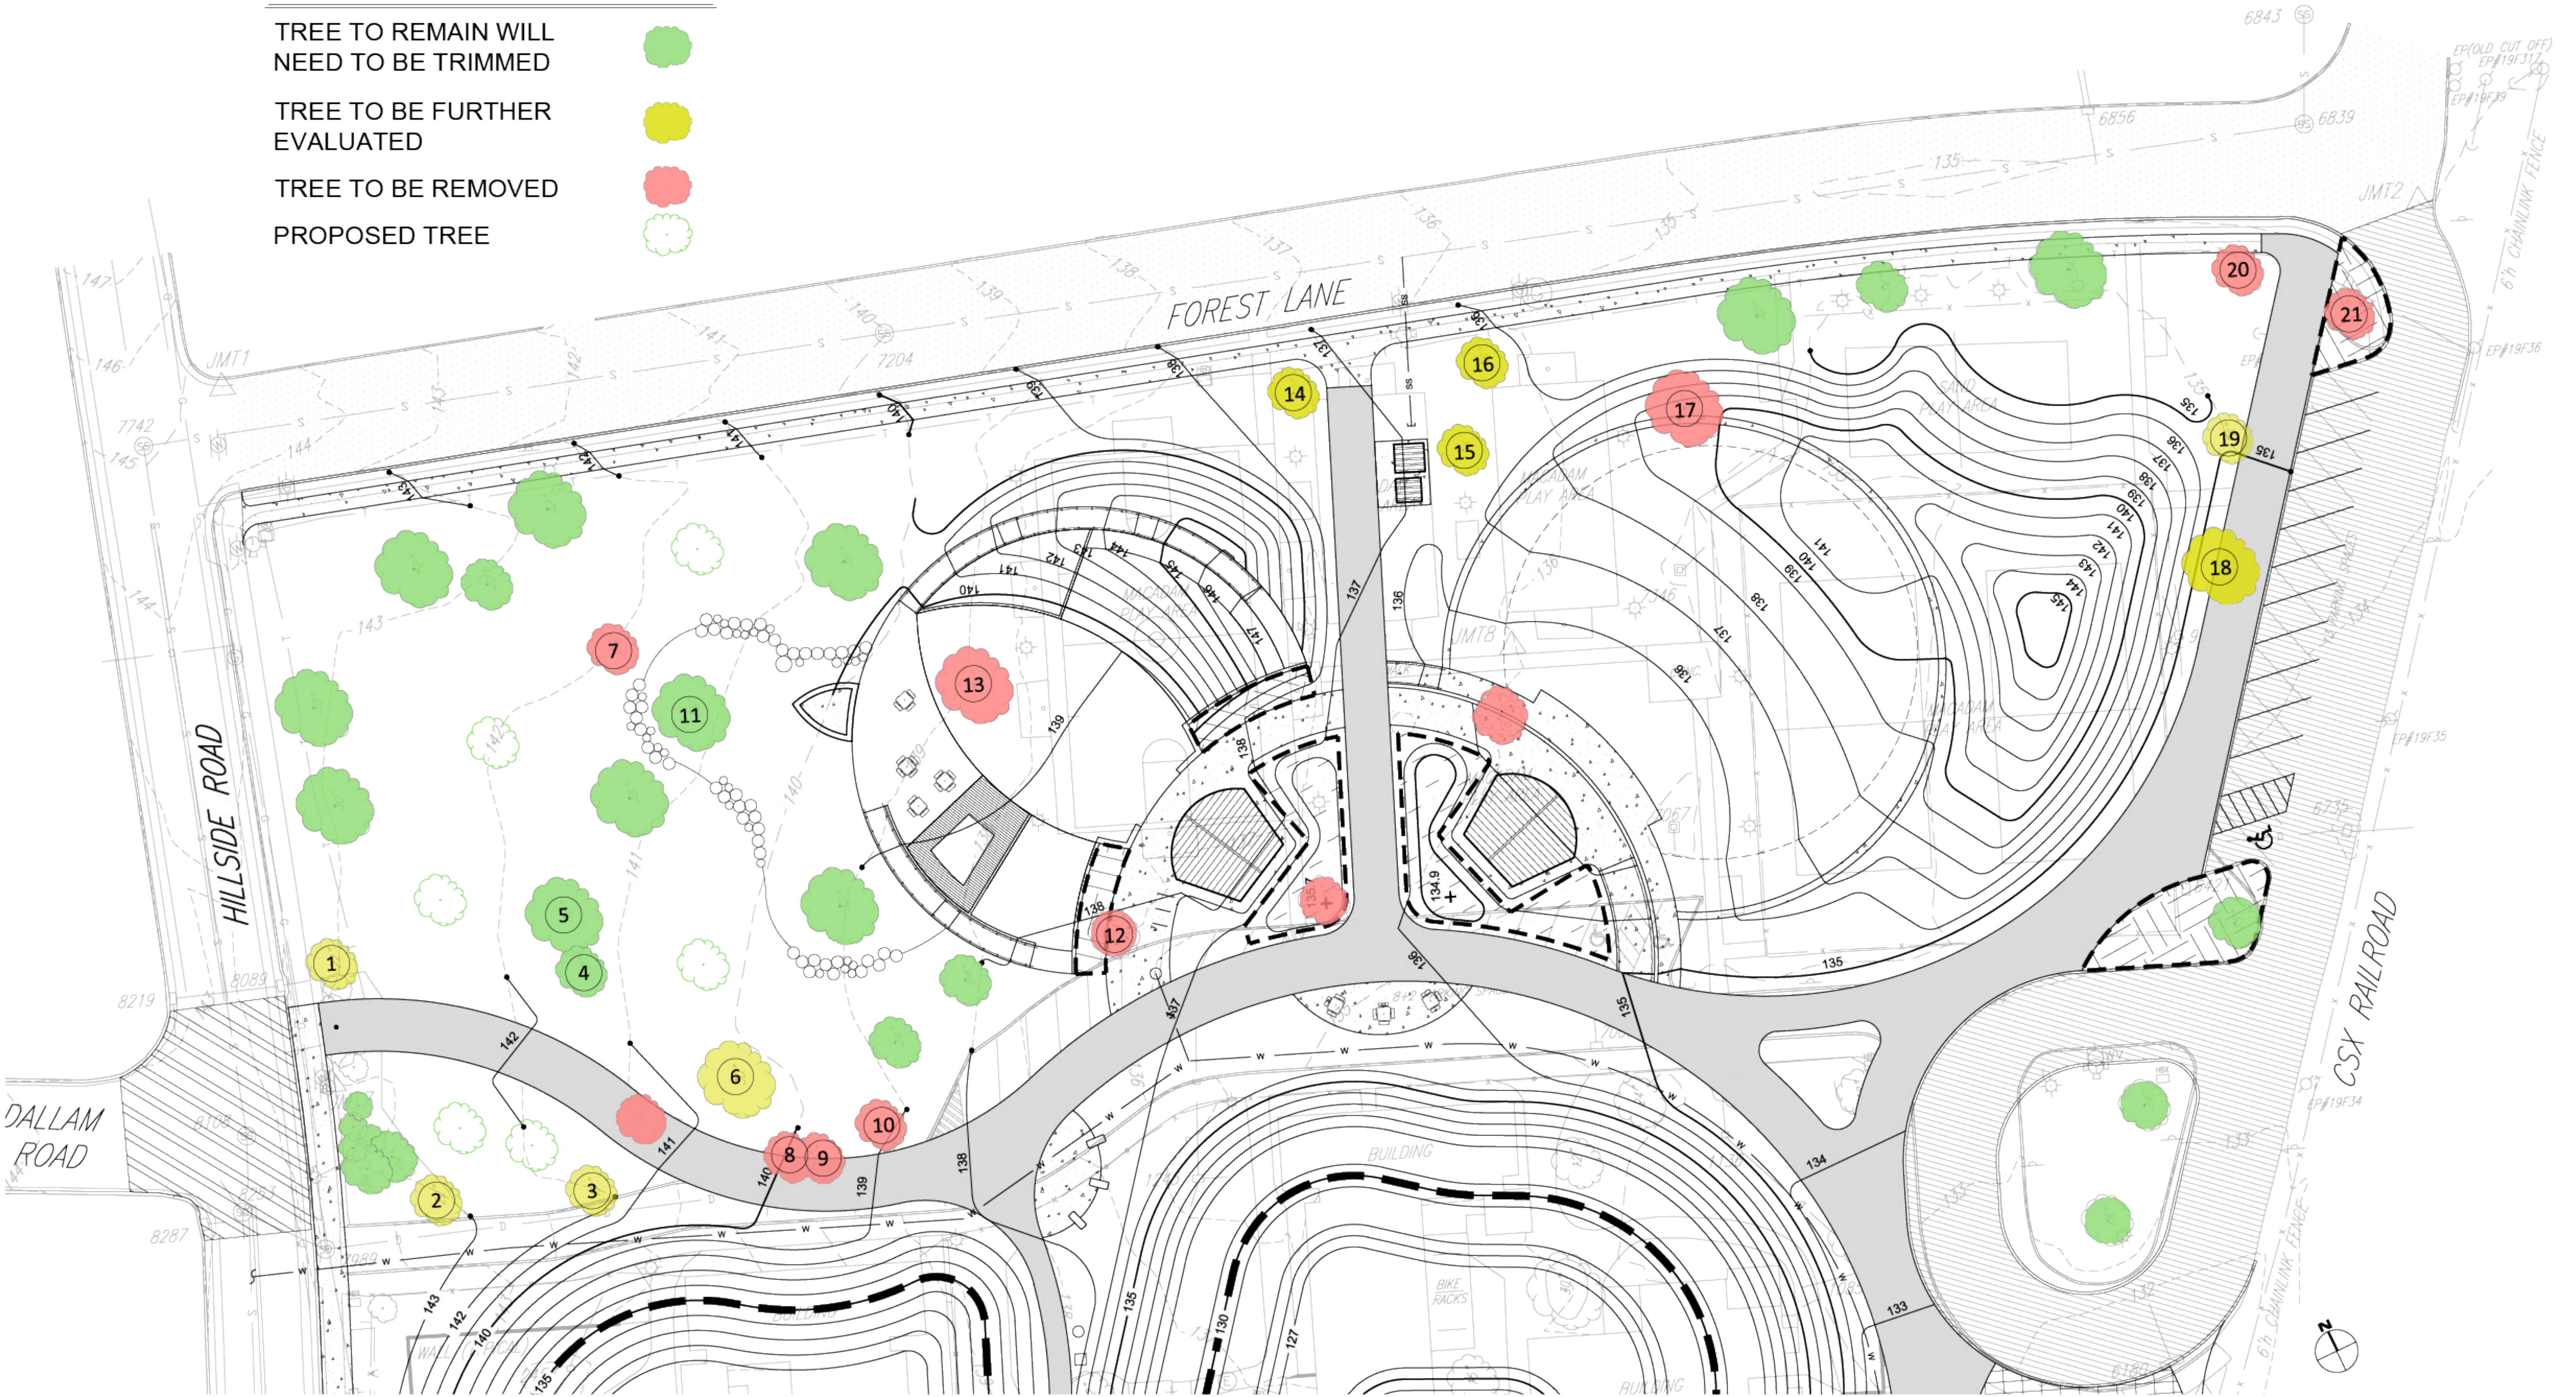
The trees marked with a white dot are considered healthy trees although they will need dead wooding and pruning. The trees that are marked with an X have some structural flaws or will be compromised due to the proposed park plans for the sight. Not all of the trees marked with an X have to be removed, pending the results of the Tree Risk Assessment Study which will be conducted by an independent ISA Arborist.

1. **Sweet Gum** – Has girdling roots with several large broken branch stubs throughout the crown of the tree. The crown also has the early stages of decline and is beginning to be seen throughout the tree. Due to the new path location, there is potential the root structure will be damaged.

2. **Sweet Gum** – The root flare is buried. When removal of existing curb line and road, there is potential the root structure will be damaged.
3. **Sweet Gum** – When removal of the existing curb line and road, there is potential the root structure will be damaged.

4. **Sweet Gum** – The crown also has the early stages of decline and is beginning to be seen throughout the tree. The root flare is buried.
5. **Sweet Gum** – The crown also has the early stages of decline and is beginning to be seen throughout the tree. The root flare is buried.

6. **Maple** – Declining in health, one lead is in severe decline.
7. **Sweet Gum** – Large cavity at the base of the tree. The tree in its existing condition is an extreme liability and needs to be removed.

8. **Sweet Gum** – Due to the removal of the existing curb and road and the installation of the new proposed path the tree will lose over 50% of its root structure.

9. **Sweet Gum** – Due to the removal of the existing curb and road and the installation of the new proposed path the tree will lose over 50% of its root structure.

10. **Persimmon** – This tree is very sensitive to changes in grade and has damage from mowers hitting it. Due to the removal of the existing curb and road and the installation of the new proposed path the tree will lose a portion of its root structure.

11. **Sweet Gum** – The root flare is buried.
12. **Honey Locust** – Located in the proposed concrete walk.
13. **Oak** – Has girdling root issue on the backside of the tree and is in the playground area that will have safety surface installed.

14. **Oak** – The tree is in good condition however, when the removal of the existing hard surface areas around the tree occur concern for root damage. If the hard surface is removed with extreme care, the tree could potentially be saved. We will reevaluate the root system after the hard surface is removed.

15. **Sweet Gum** – The tree is in good condition however, when the removal of the existing hard surface areas around the tree occur concern for root damage. If the hard surface is removed

with extreme care, the tree could potentially be saved. We will reevaluate the root system after the hard surface is removed.

16. **Oak** – The tree is in good condition however, when the removal of the existing hard surface areas around the tree occur concern for root damage. If the hard surface is removed with extreme care, the tree could potentially be saved. We will reevaluate the root system after the hard surface is removed.

17. **Oak** – The tree needs to be removed due to the grade of the area increasing and burying the root flare and root structure.
18. **Oak** – The tree is in good condition however, due to the proposed location of the new walkway approximately 50% of the root structure could be compromised.

19. **Oak** – The tree is in good condition however, due to the proposed location of the new walkway approximately 50% of the root structure could be compromised.

20. **Maple (Boxelder)** – The tree is in severe decline and needs to be removed.
21. **Honey Locust** – Root damage to the tree and half of the crown has been removed due to hard pruning because of the overhead power line. The tree needs to be removed.
